TS-PIC-20304515S
March 2003

AERIAL PHOTOGRAPHIC ANALYSIS OF HENRY'S KNOB SITE Clover, South Carolina

Clover, South Carolina

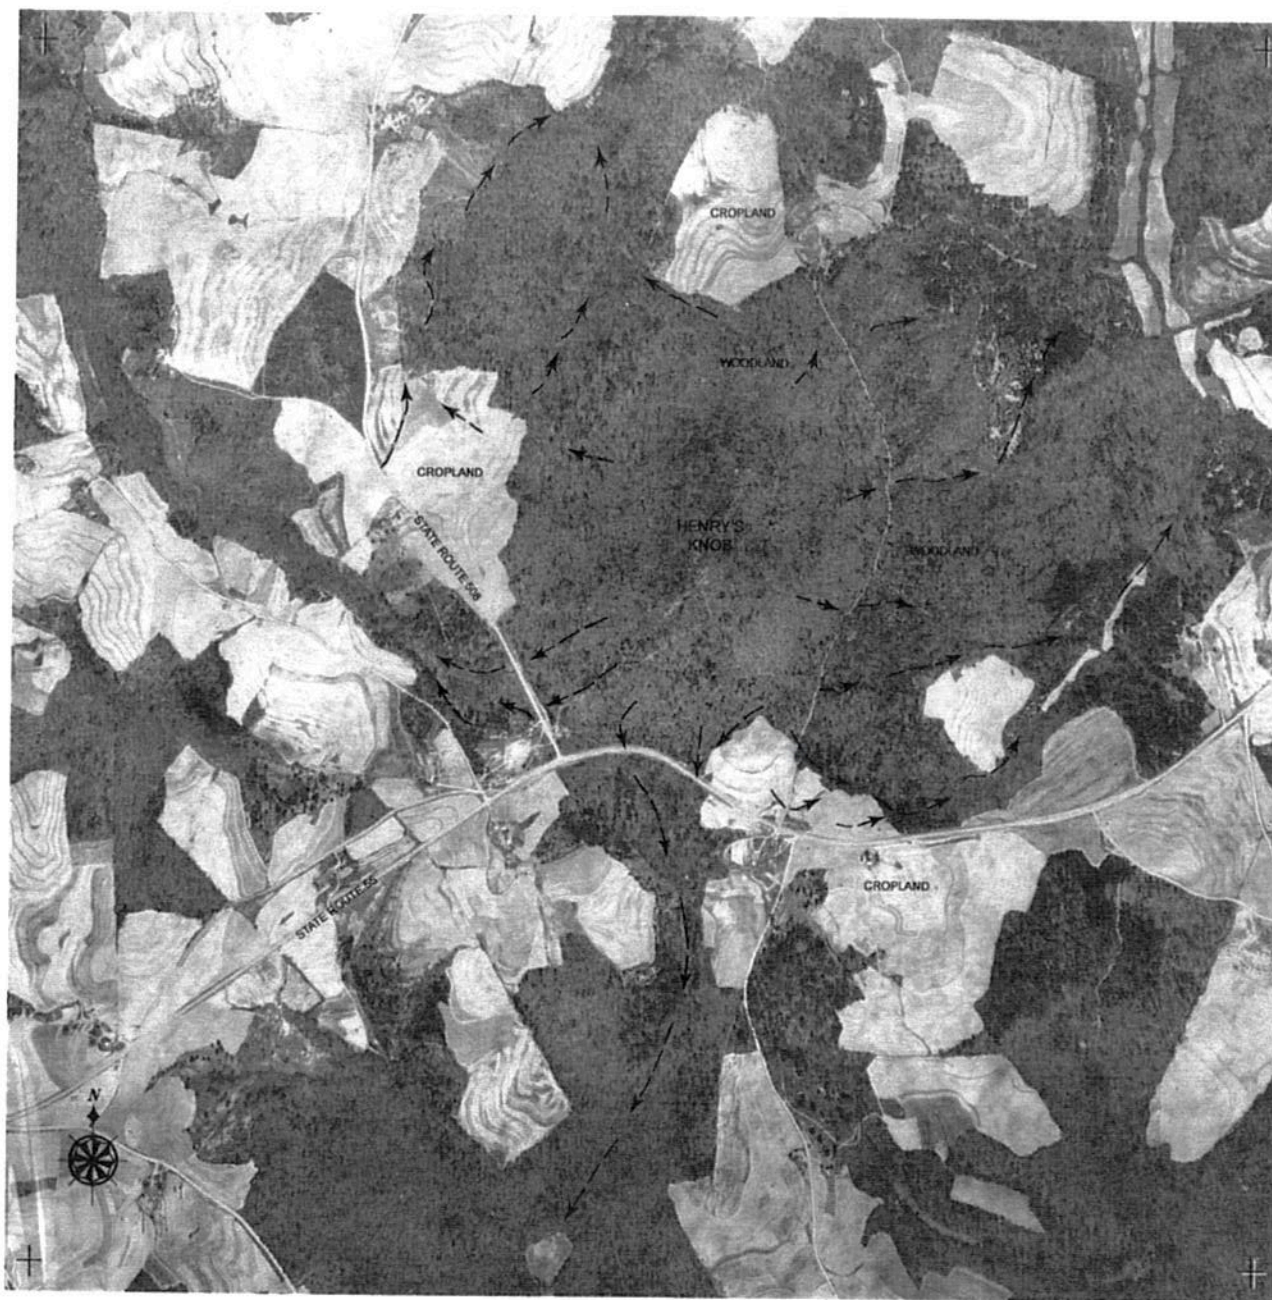
Figure 3. Henry's Knob site, April 12, 1941. Approximate scale 1:10,800.

The 1941 photograph shows the condition of the site and the topography of Henry's Knob prior to the establishment of mining and milling activities. At the summit of Henry's Knob a rock escarpment (not annotated) is visible and the surrounding slopes of the knob are woodland. Areas of terraced cropland are visible to the north, south, and west of the rock escarpment. No excavation activity is discerned.

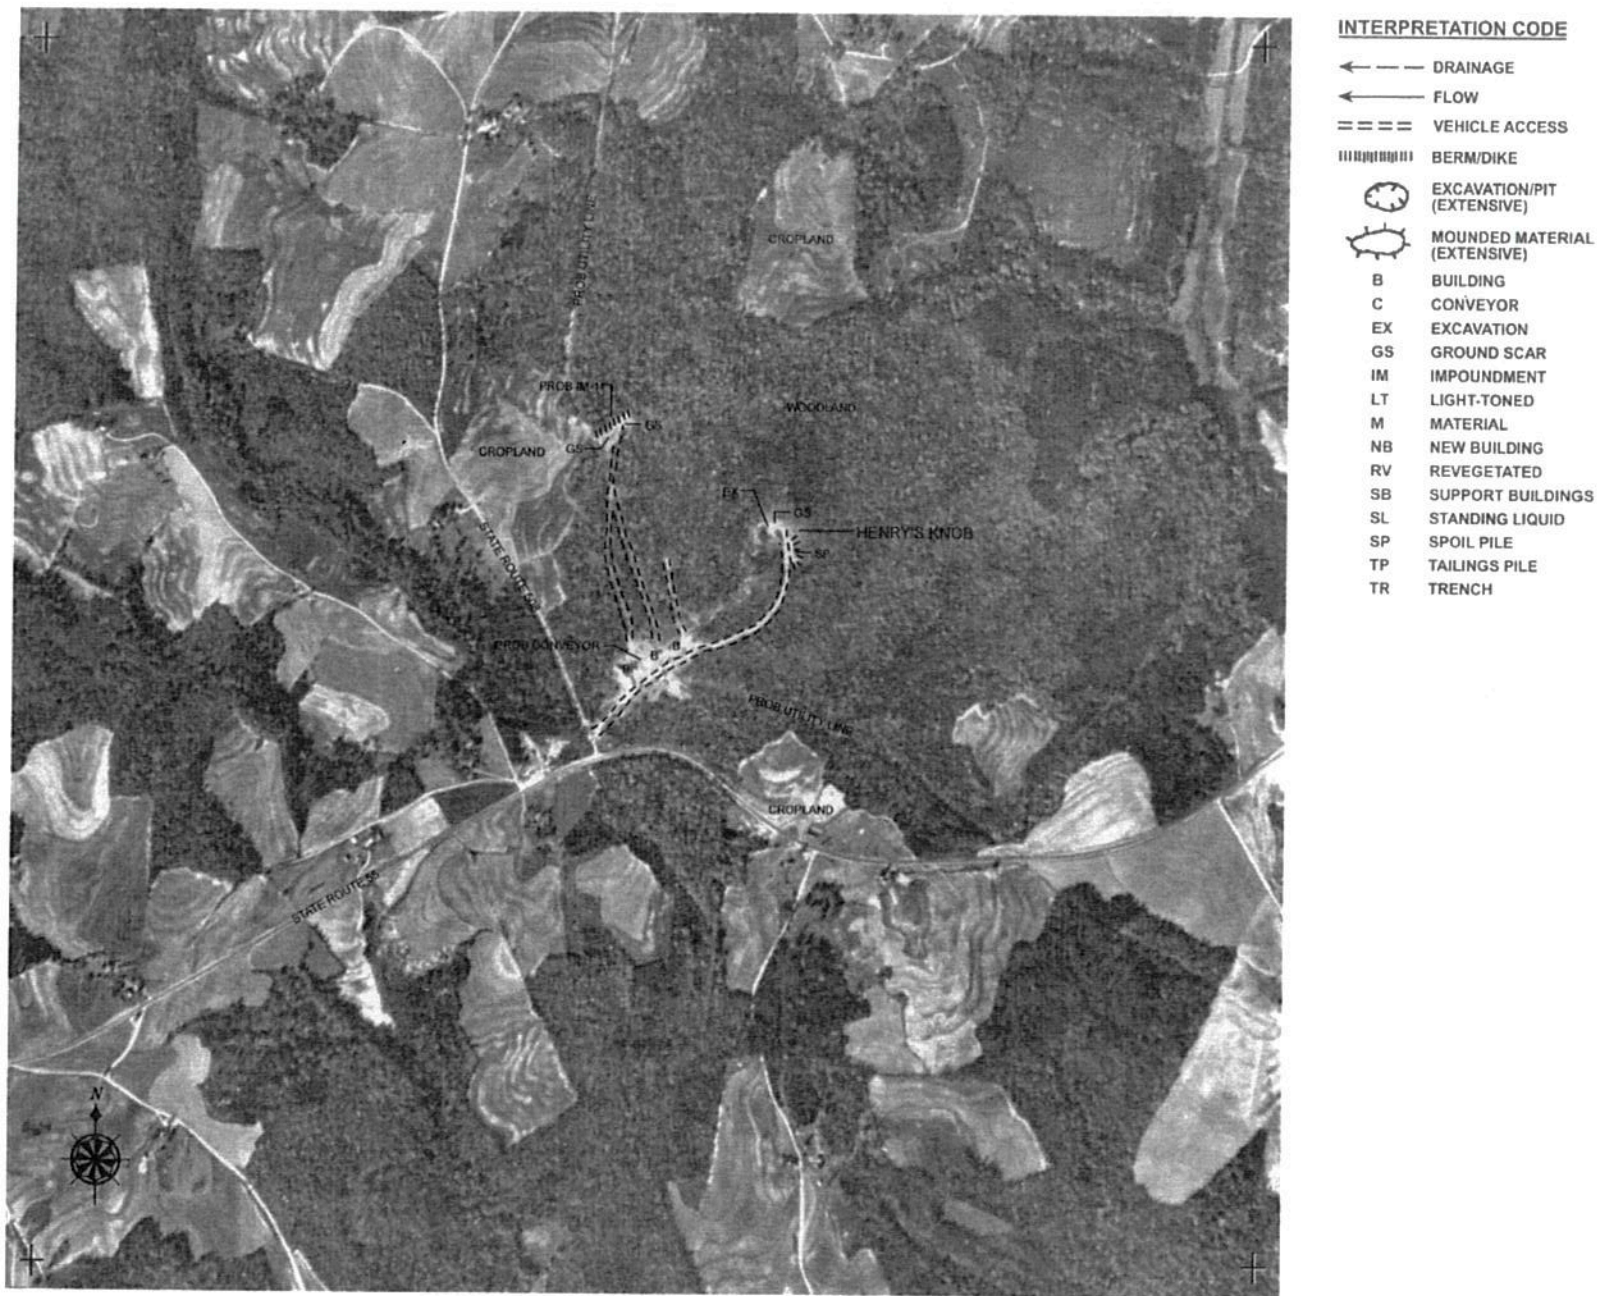
Figure 4. Henry's Knob site, November 12, 1949. Approximate scale 1:11,200.

Mining operations are observed at the site. An unpaved access roadway trending to the northwest from State Route 508 has been constructed up the hillside of Henry's Knob and provides vehicle access to its summit. A visible ground scar (GS) reveals earthmoving and excavation activity at the north end of the rock escarpment. A spoil pile (SP), presumably consisting of the removed rock and soil overburden, has been deposited a short distance from an excavation area at the northern terminus of the access roadway.

A grouping of five mill buildings (B) (three of which are annotated) have been constructed along the southwestern slope of Henry's Knob. These mill buildings are situated at differing elevations on the terrain gradient. Within this mill complex, several of the buildings are connected by structures that are probable conveyors (partially annotated).

A vehicle roadway has been established into a remote area north of the mill buildings. The visible ground scars suggest that a probable impoundment (IM-1) is under construction at this location.

To the northwest and southeast of the mill complex, a visible cleared corridor cutting through the woodland indicates that probable utility lines now serve the mill complex at Henry's Knob. This probable utility line and corridor will no longer be annotated or discussed, unless features or activities of environmental significance associated with are discerned.

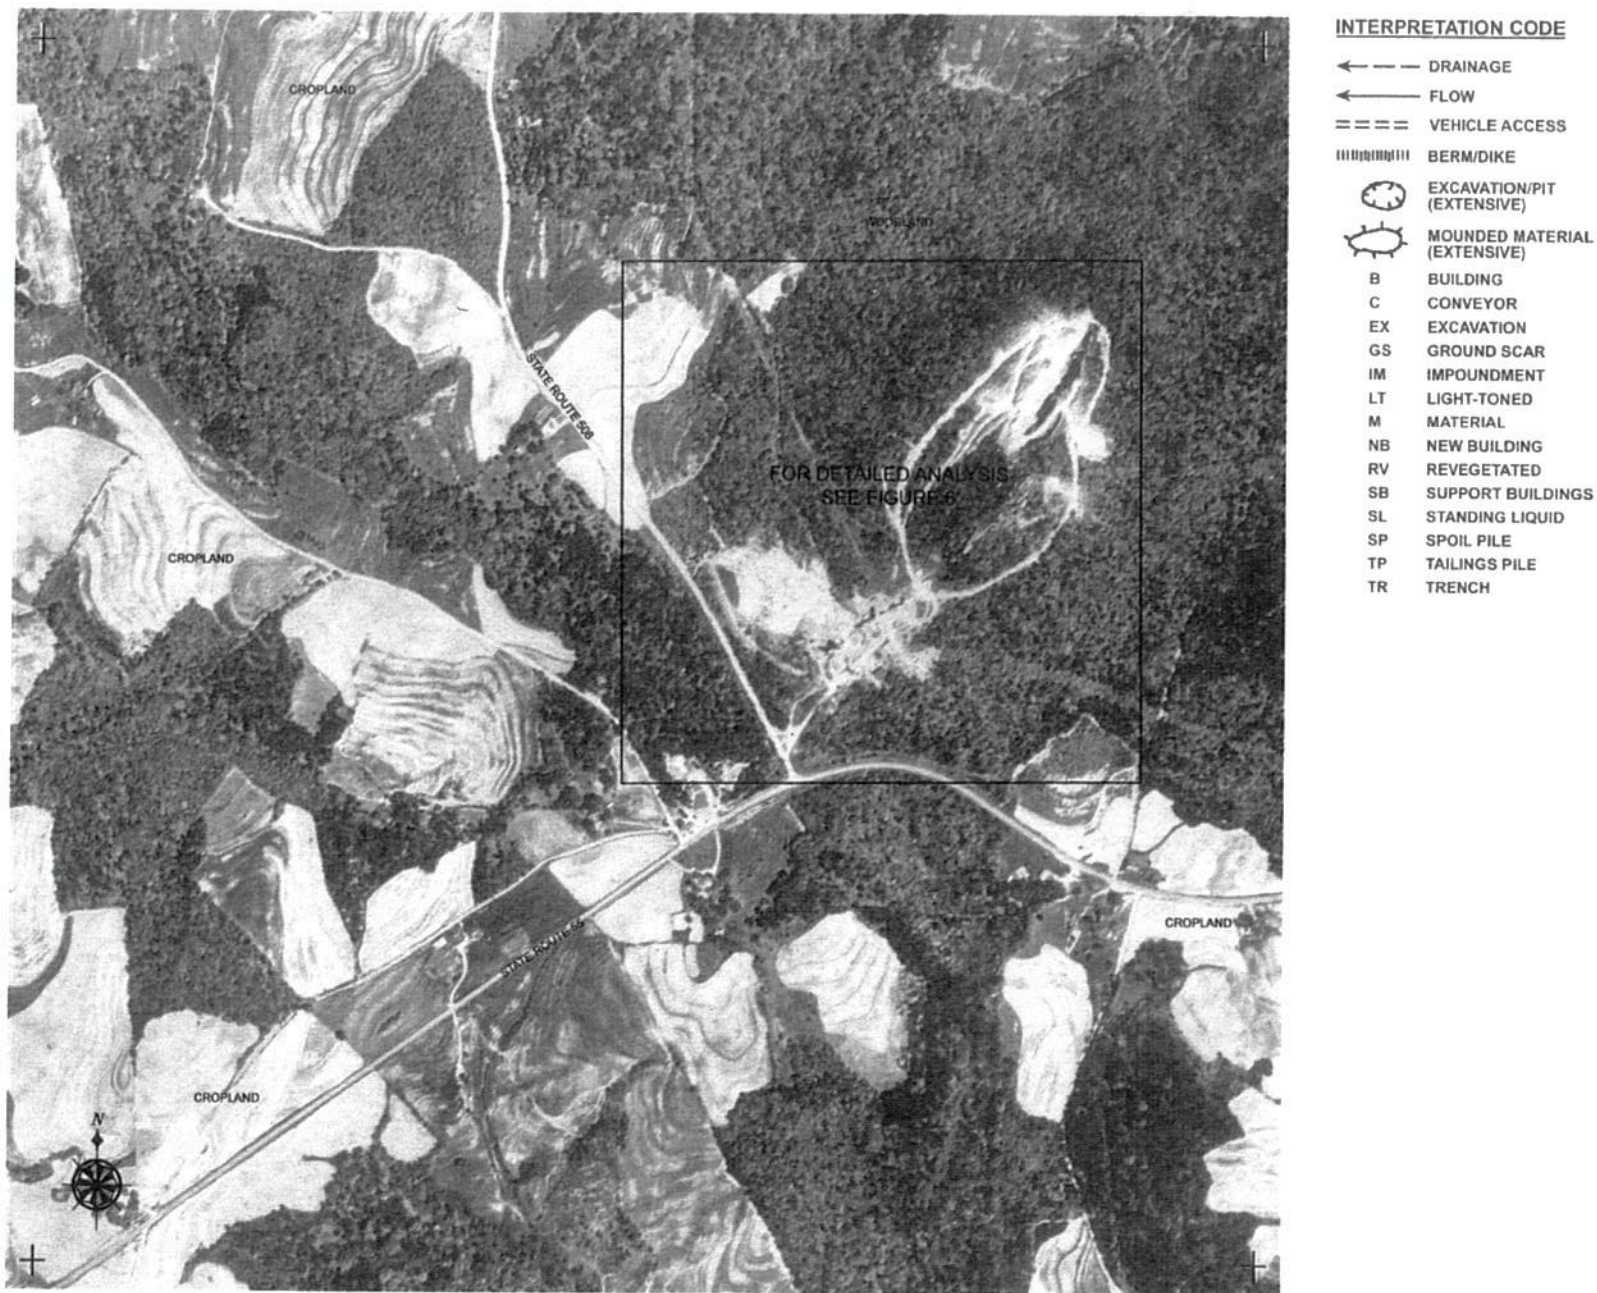
Figure 5. Henry's Knob site, April 19, 1954. Approximate scale 1:7,300.

The mining and milling operations have continued at the site since 1949. An excavated, open pit mine is now visible along the summit of Henry's Knob. The access roadway now encircles the summit and provides access to the open pit mine from both the northeast and southwest. Two light-toned spoil piles have been deposited short distances from the open pit mine, one along the north and the other on the southeast slope of Henry's Knob. A smaller excavation has also been dug to the south of the open pit mine.

Southwest of the open pit mine a total of nine mill buildings and five support buildings (SB) are now observed within the mill complex. A probable trench (TR) is observed at the north end of the mill complex. The function of this probable trench could not be determined, however. Typically gravity is used to transport ore through the stages of the milling processing. The mill buildings appear to conform to this layout design, as several of them are connected by a conveyor system (C), aligned downgradient from one another.

The construction of impoundment IM-1 has been completed downhill from and northwest of the mine pit. This impoundment contains light-toned material (LTM), which evidently has been transported by runoff, as no pipes or other conveyance system are discerned leading to the impoundment. Two roadways are observed linking this impoundment to the mill complex to the south.

A large, light-toned probable tailings pile (TP) has been deposited downhill and northwest from the mill complex. A second large impoundment (IM-2) has been built downgradient from this tailings pile just along the east side of Route 508. Impoundment IM-2 contains the light-toned probable tailings (mentioned above) and standing liquid (SL) presumed to be surface water runoff.

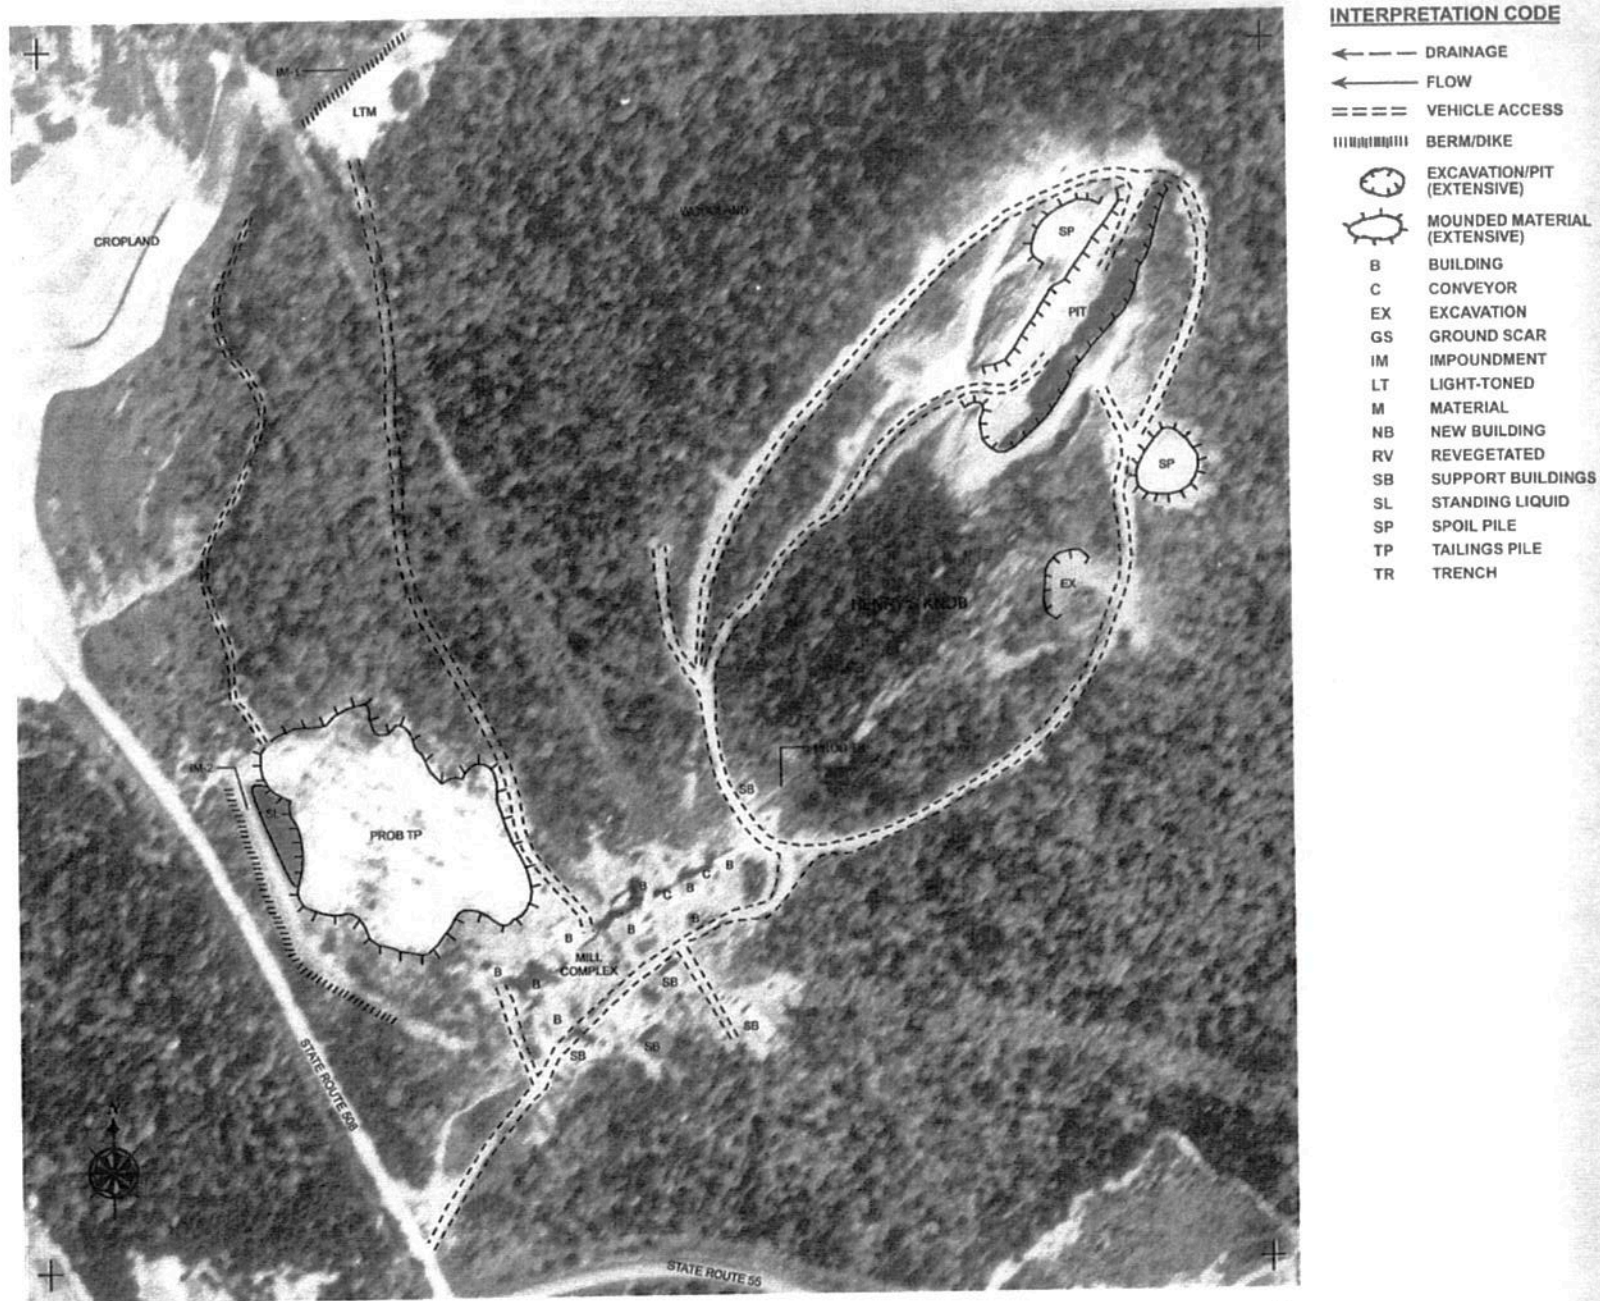
Figure 6. Henry's Knob site, April 19, 1954. Approximate scale 1:2,800.

A photographic enlargement has been provided to better show details of features of environmental concern at the Henry's Knob site. A square-box annotation on Figure 5 delineates the area that has been photographically enlarged as Figure 6.

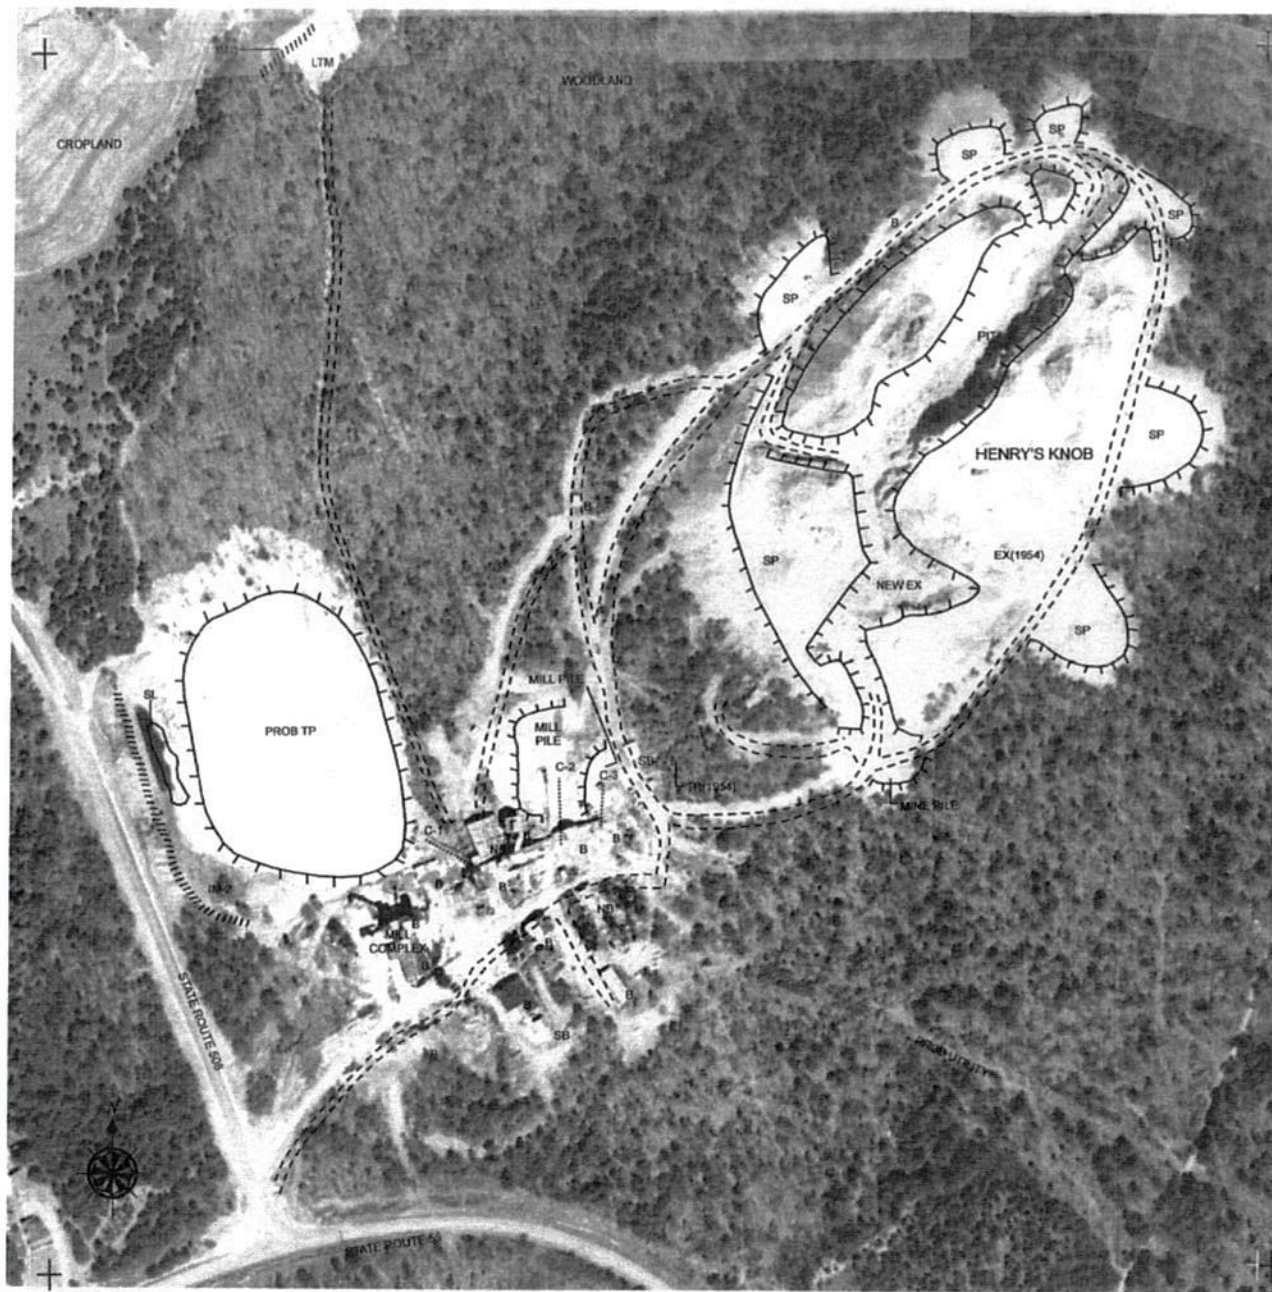
Figure 7. Henry's Knob site, April 3, 1959. Approximate scale 1:2,800.

Excavation activity has expanded the size of the open pit mine. This excavation has altered the shape of Henry's Knob terrain and has resulted in the deposition of several large, light-toned spoil piles along the outer rim of the pit.

There are no significant changes noted at impoundment IM-1 which continues to contain light-toned material.

Within the mill complex two new buildings (NB) and three conveyors (C-1, C-2, and C-3) are discerned. These conveyors appear to be for the transport of material to mill piles situated on the north side of the mill complex. These piles presumably contain crushed ore or mill tailings. To the west the large probable tailings pile located within impoundment IM-2 is linked to conveyor C-1. This deposit has been expanded in size since 1954. To the west the adjacent area of standing liquid continues to be visible.

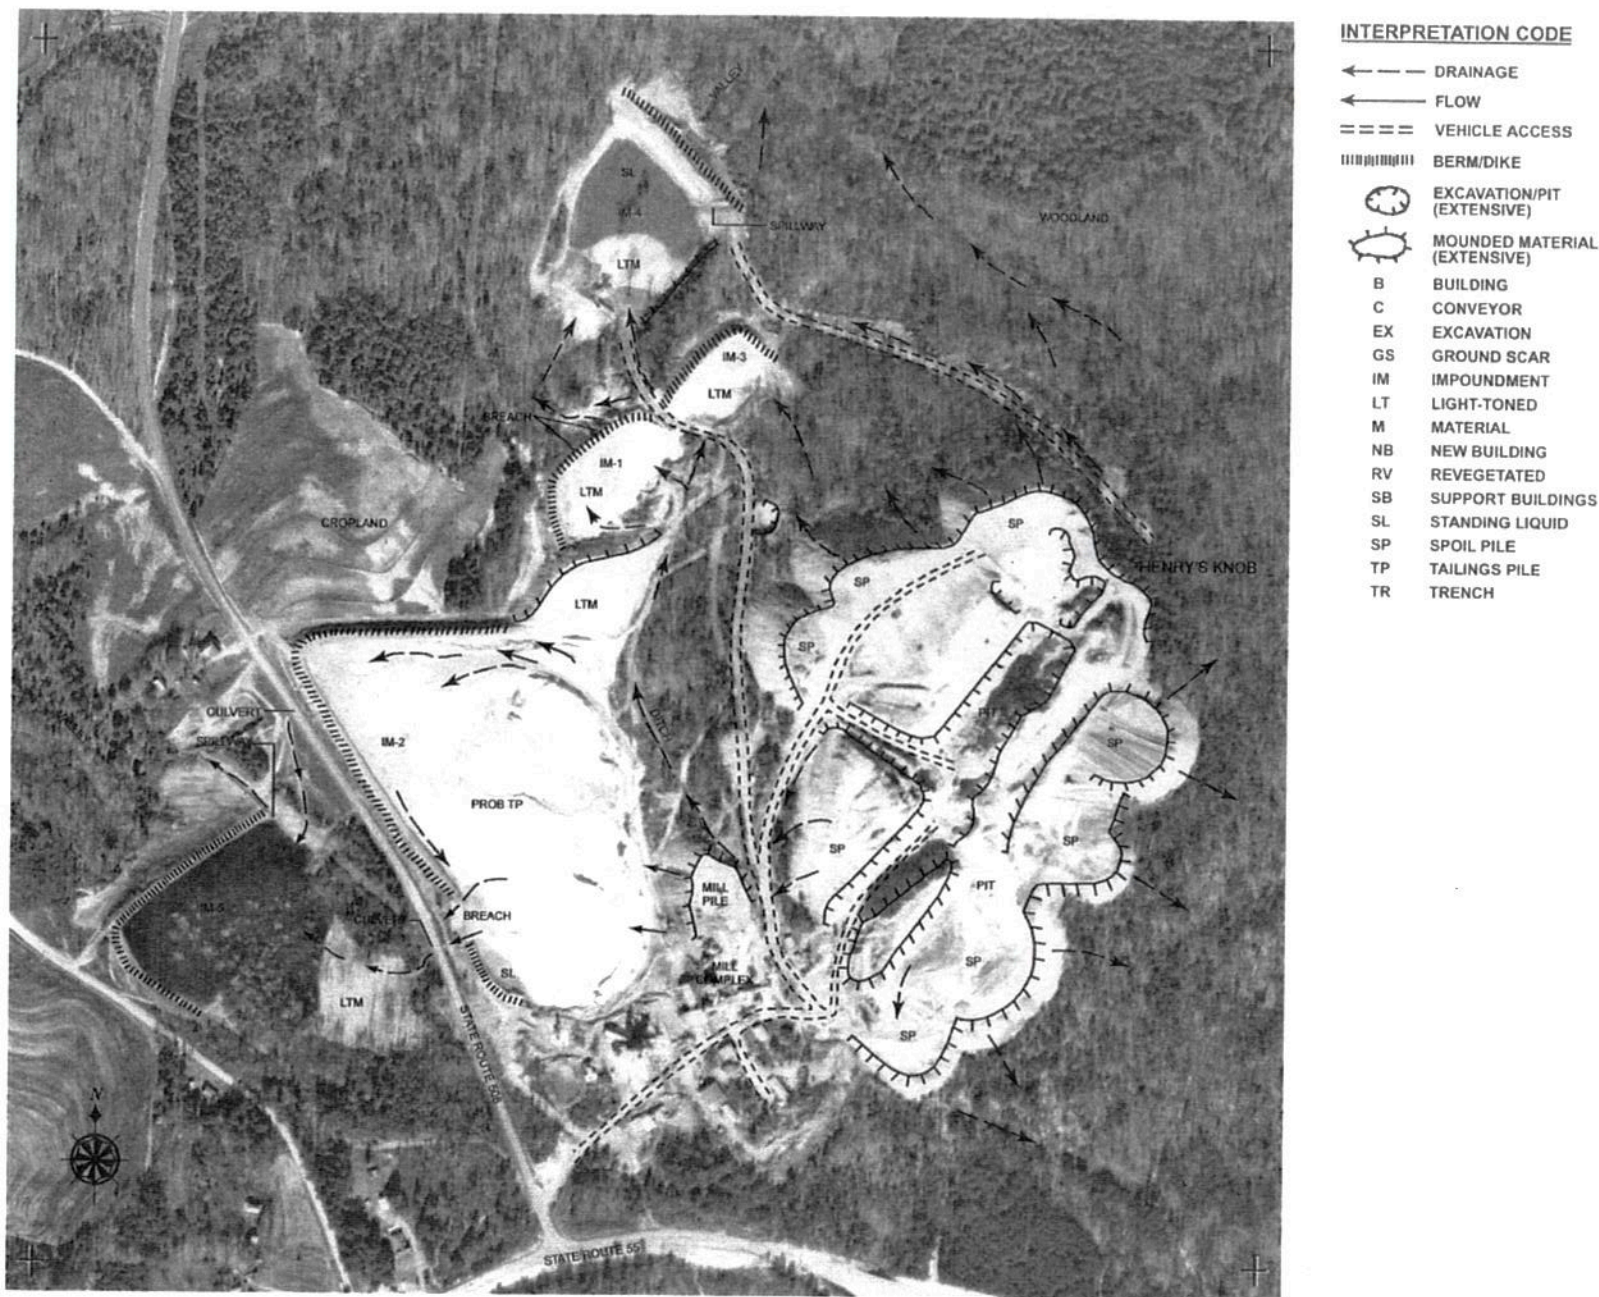
Figure 8. Henry's Knob site, November 21, 1964. Approximate scale 1:4,000.

Excavation activity within the open pit mine has continued since 1959. Several new access roads serve the mine pit which has been enlarged to the south and encompasses the entire summit of Henry's Knob. With the ongoing excavation activity within the mine, the number and size of the spoil piles deposited along the rim of the mine have also increased. Dark shadows (not annotated) obscure the base of the mine pit and preclude discerning features in this area.

No new construction or dismantling of buildings is apparent within the mill complex since 1959 (structures not annotated). However, the conveyors previously noted at the mill are not evident (not annotated).

The volume of the probable tailings deposit has been increased with the expansion of the containment berm of impoundment IM-2. The enlarged IM-2 now extends north and has become contiguous with impoundment IM-1. New impoundment IM-3 has been constructed on the north side of impoundment IM-1 and contains light-toned material, which is evidently overflow of material from impoundment IM-1.

Two breaches are indicated by erosion rills along the north face of containment berm of impoundment IM-1. Runoff passing through these breaches appears to flow into recently constructed impoundment IM-4 that spans a valley downhill from impoundment IM-1. A new access road runs along the north side of Henry's Knob and was presumably used during the construction of impoundment IM-4. Currently light-toned material (probable tailings) and standing liquid are visible within impoundment IM-4. A spillway has been built within the rim of the containment berm that forms impoundment IM-4. Potential drainage leaving impoundment IM-4 would enter the natural drainage system in the valley below and, thus, could threaten the South Fork Crowders Creek.

Another new, large impoundment (IM-5) has been constructed downgradient from impoundment IM-2 on the west side of Route 508. Impoundment IM-5 contains standing liquid and light-toned material (probable tailings). Tailings transported by runoff could escape impoundment IM-2 from a breach located in the southwestern portion of the containment berm. The drainageway passes west

through a culvert under Route 508 near the northwestern corner of IM-2. There appears to be a spillway constructed along the northeast edge of the berm forming impoundment IM-5. Potential liquid draining from impoundment IM5 would enter the valley and the natural drainage system to the northwest and could threaten the South Fork Crowders Creek.

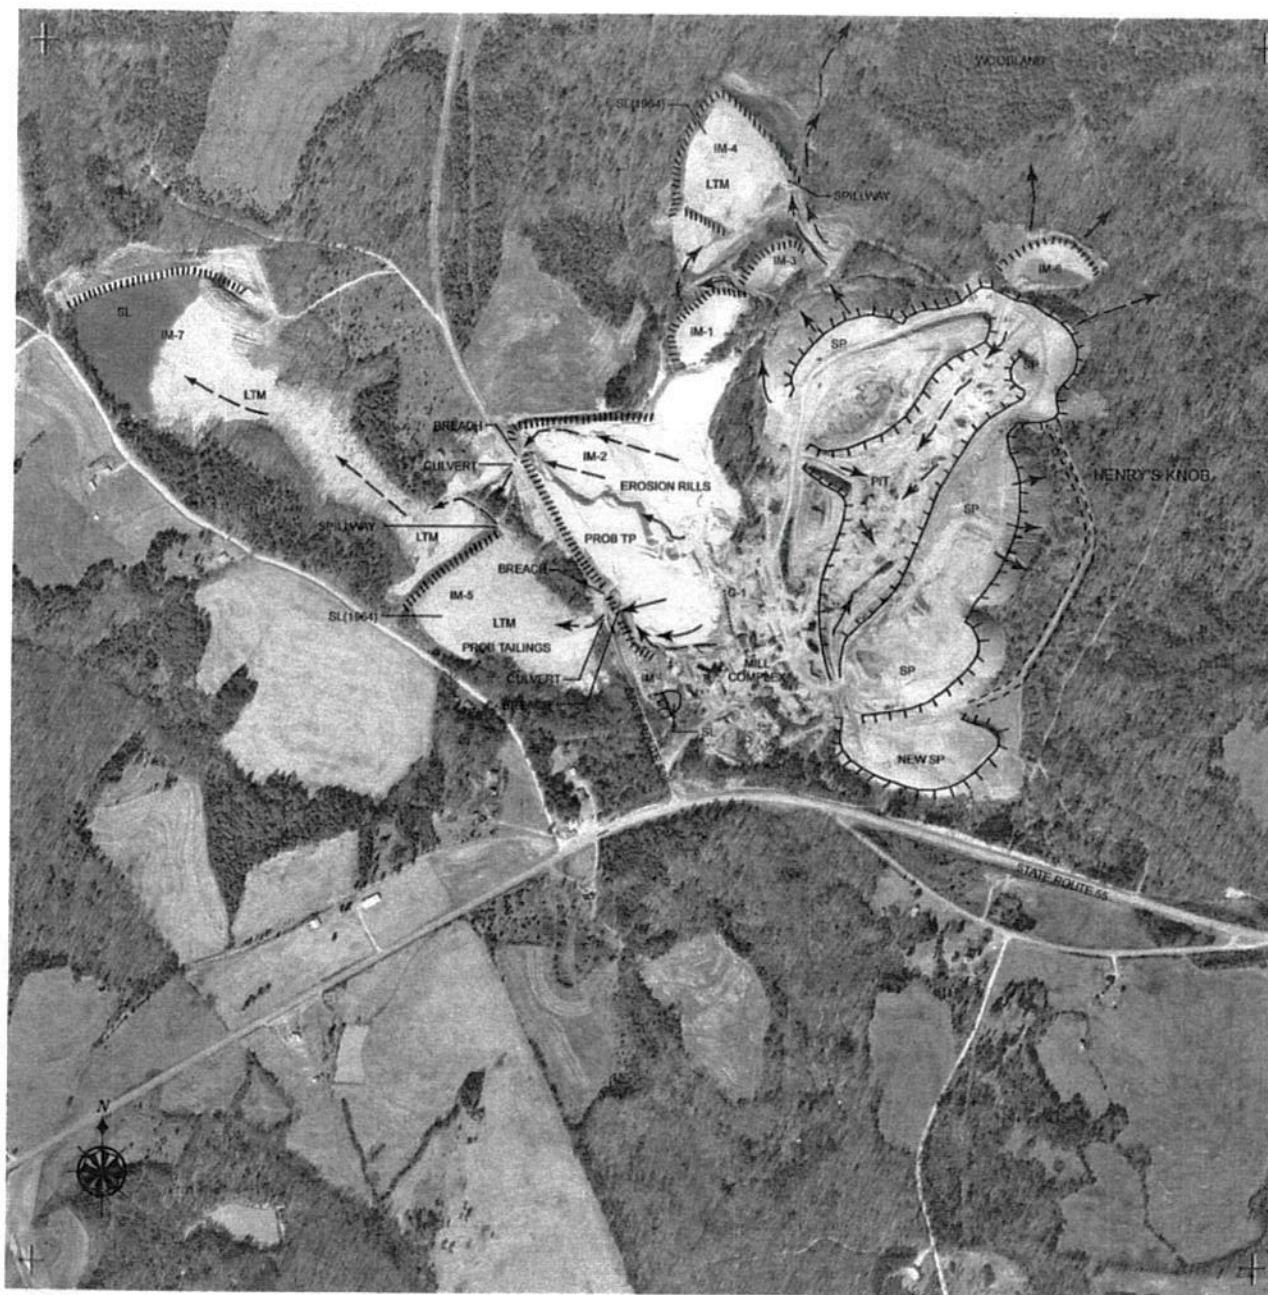
Figure 9. Henry's Knob site, February 20, 1970. Approximate scale 1:7,500.

The mining and milling activities at the Henry's Knob site have continued. The size of the open pit mine has been expanded since 1964 and the size of the spoil piles have also increased along both the north and south outer rims of the mine. A new impoundment (IM-6) has been constructed on the north side of the Henry's Knob. At the south side of Henry's Knob, a new spoil pile has been deposited to the east of the mill complex, near the north side of Route 55.

In the northern portion of the site, impoundment IM-4 continues to retain light-toned material; however, the standing liquid noted in 1964 is not evident. Impoundment IM-4 appears to capture runoff from impoundments IM-1 and IM-3. Potential liquid draining from impoundment IM-4 via the spillway would enter the natural drainage system and could threaten the South Fork Crowders Creek.

Within the mill complex no new construction or dismantling of buildings (structures not annotated) is apparent since 1959, and all of the mill buildings appear operational. The conveyor C-1 appears to be present, but has been repositioned since 1959. The other previously noted conveyors are not evident. Erosion rills are visible within the mill complex and a small impoundment (not numerically designated), which contains standing liquid, has been built at the south end of the mill complex and evidently captures runoff.

To the north deep erosion rills are visible in the probable tailings within impoundment IM-2 and large breaches are visible in the containment berm of this impoundment. Drainage patterns reveal runoff flows west from impoundment IM-2 and enters impoundment IM-5 located on the west side of Route 508. The light-toned material observed within impoundment IM-5 is probable tailings. The standing liquid observed within impoundment IM-5 on the 1964 photograph is no longer discerned.

Another new impoundment (IM-7) has been constructed within the same valley and downgradient from where impoundment IM-5 is situated and has flooded the valley behind it. Impoundment IM-7 contains both standing liquid and light-toned material; trees are still visible standing in this impoundment. Drainage patterns indicate runoff would overflow impoundment IM-5 via a spillway and could enter impoundment IM-7. Any potential overflows (not annotated) from impoundment IM-7 would enter the valley, and flow into the natural drainage system before eventually threatening the South Fork Crowders Creek.

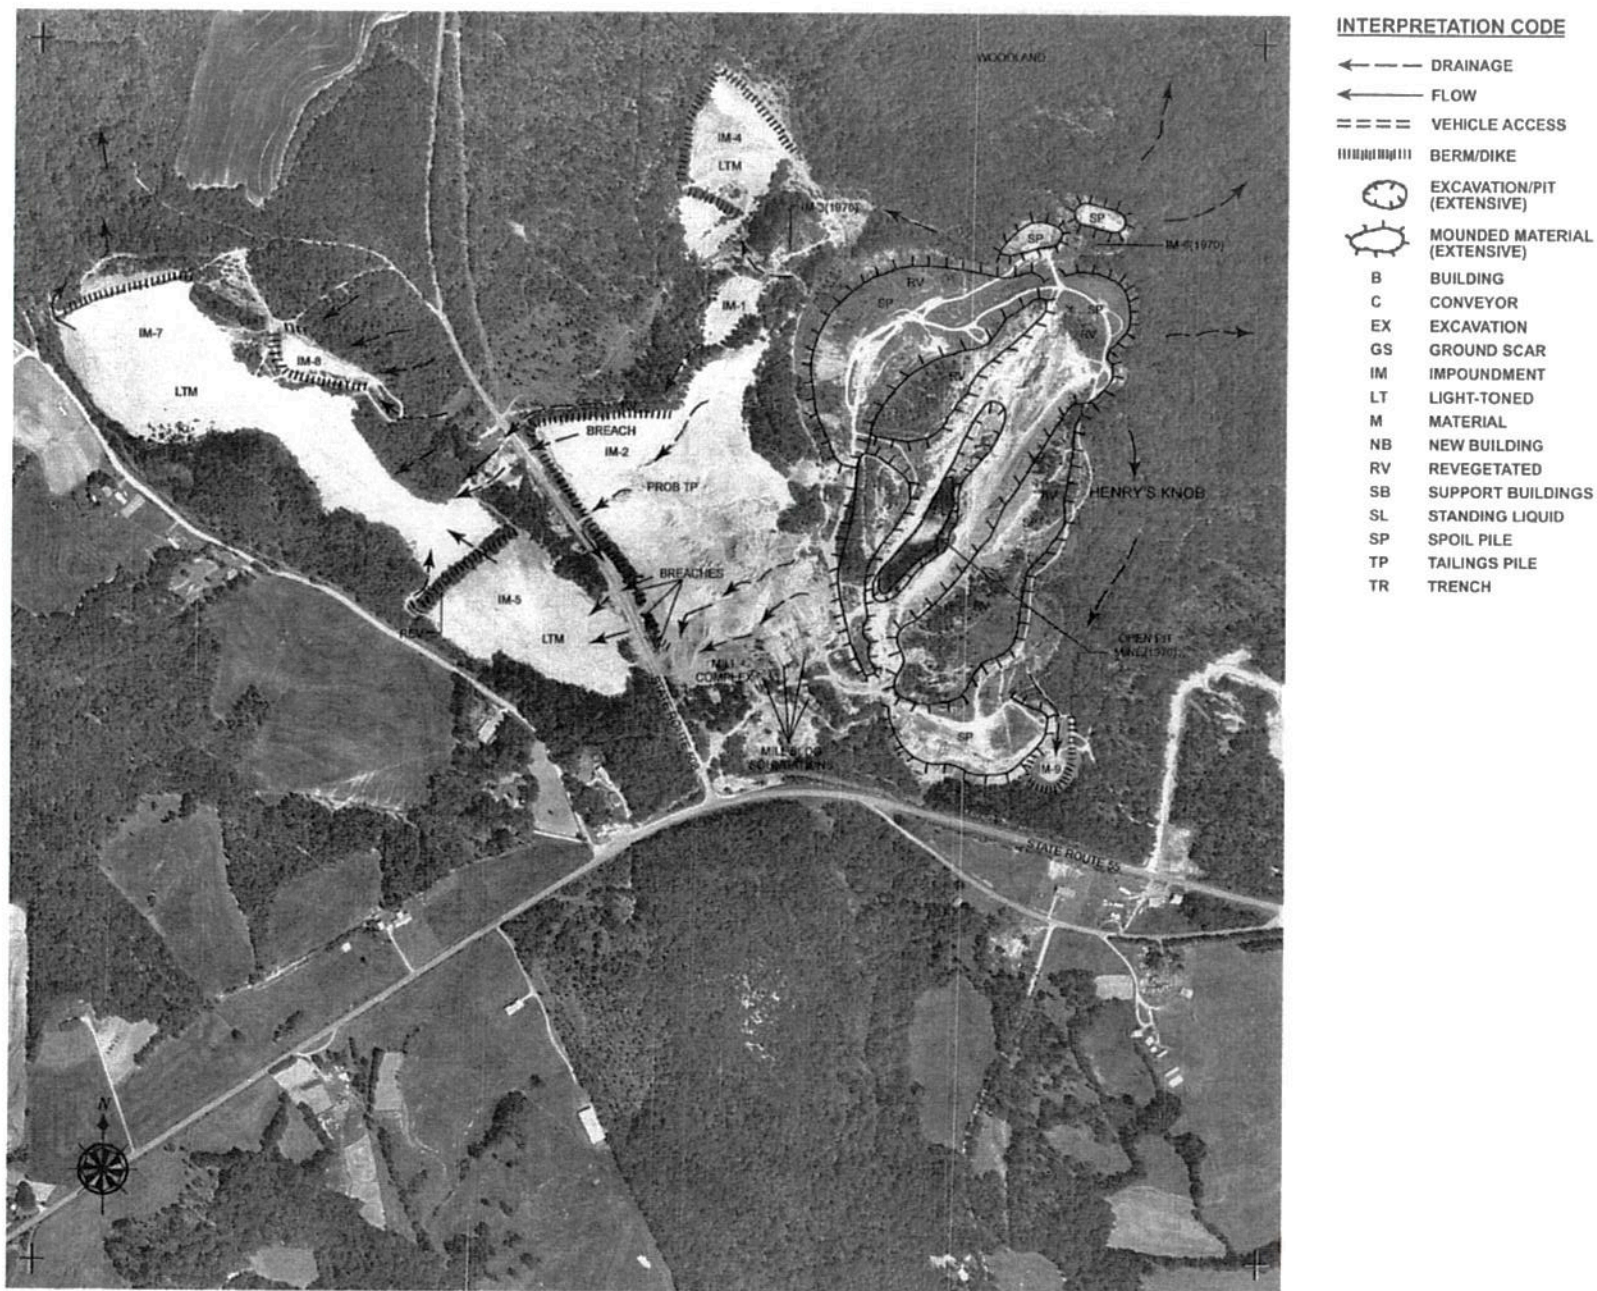
Figure 10. Henry's Knob site, April 28, 1981. Approximate scale 1:7,500.

The mining and milling operations at the Henry's Knob site are no longer active. All mill buildings and structures noted in the 1970 photograph have been dismantled and removed and only building foundations remain. Ground scars and vehicle roadways (features not annotated) are also visible throughout former mill complex as well as in the inactive open pit mine. The open pit of the former mine is now partially flooded. The large spoil piles noted along the outer rim of pit mine have been abandoned in place. Most of these spoil piles have become partially revegetated (RV).

To the northwest of Henry's Knob, impoundment IM-4 still contains light-toned material that is devoid of vegetation, while the former impoundment IM-6 north of the mine pit is no longer discernible and is overgrown with vegetation (not annotated). The spoil piles more recently deposited on the north side of the former impoundment IM-6 have only sparsely revegetated.

Erosion rills (not annotated) remain visible on the light-toned probable tailings deposit within impoundment IM-2. The light-toned material visible within most of the impoundments IM-1 through IM-7, which are probable tailings transported by runoff, generally appears to be devoid of vegetation. The visible breaches in the containment berms of impoundments IM-2 and IM-5 suggests tailings have migrated from impoundment IM-2 to impoundment IM-7. On the west side of Route 508, downgradient from impoundment IM-5, a new impoundment (IM-8) has been constructed adjacent to impoundment IM-7. This new impoundment appears to capture additional runoff draining from the northwest side of Henry's Knob.

In the southeastern corner of the site, another new impoundment (IM-9) has been constructed. This impoundment captures runoff draining from the east side of Henry's Knob, particularly from the spoil piles on the southeast side of the mine rim.
